**DEPARTMENT OF TRANSPORTATION****DIVISION OF ENGINEERING SERVICES**

Contract #: 04-0120F4Cty: SF/ALA Rte: 80 PM: 13.2/13.9File #: 69.28**WELDING INSPECTION REPORT****Resident Engineer:**Pursell, Gary**Address:** 333 Burma Road**City:** Oakland, CA 94607**Report No:** WIR-015929**Date Inspected:** 29-Jul-2010**Project Name:** SAS Superstructure**OSM Arrival Time:** 700**Prime Contractor:** American Bridge/Fluor Enterprises, a JV**OSM Departure Time:** 1900**Contractor:** Zhenhua Port Machinery Company, Ltd (ZPMC), Changxing Island **Location:** Shanghai, China**CWI Name:** Mr. Li Jia**CWI Present:** Yes No**Inspected CWI report:** Yes No N/A**Rod Oven in Use:** Yes No N/A**Electrode to specification:** Yes No N/A**Weld Procedures Followed:** Yes No N/A**Qualified Welders:** Yes No N/A**Verified Joint Fit-up:** Yes No N/A**Approved Drawings:** Yes No N/A**Approved WPS:** Yes No N/A**Delayed / Cancelled:** Yes No N/A**Bridge No:** 34-0006**Component:** Orthotropic Box Girder( OBG)**Summary of Items Observed:**

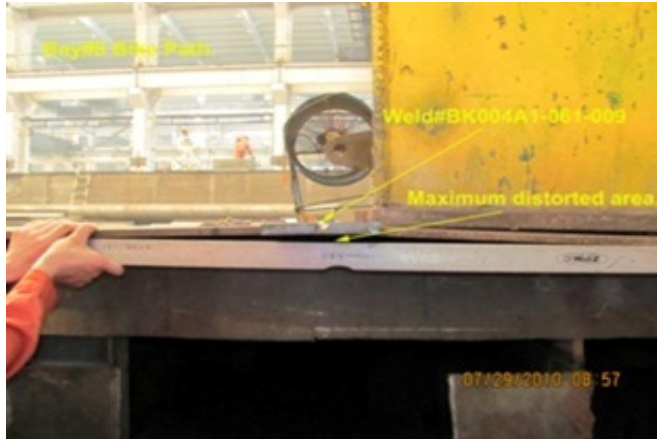
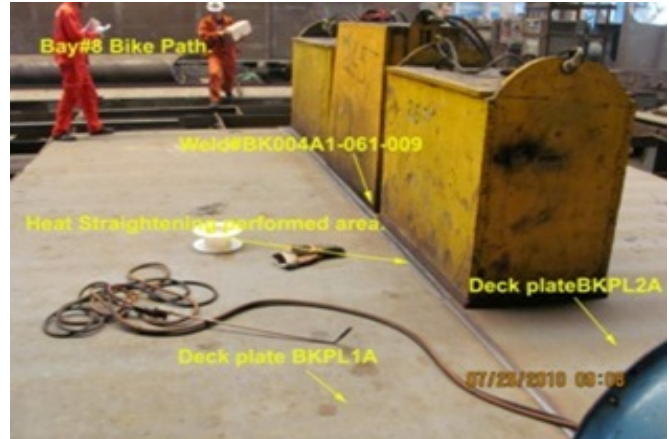
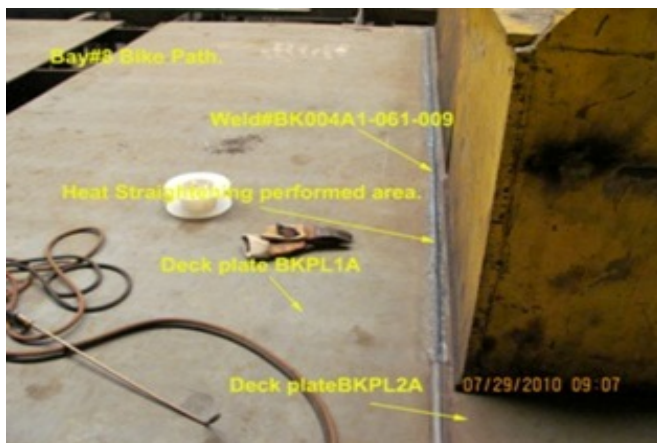
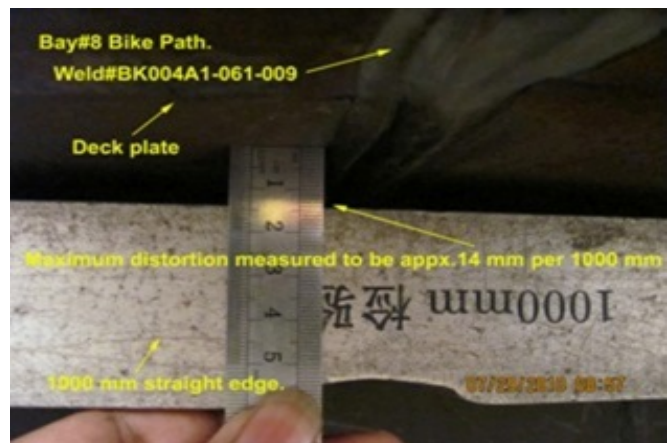
During the Caltrans Quality Assurance in-process observations of the fabrication of Bike Path(BK) BK004A1-061, this QA Inspector observed ZPMC personnel performing heat straightening on the Top Plate of the bike path which is distorted approx. 15mm in 1000mm. The heat straightening was performed without the engineer's approval. The Bike Path is identified as BK004A1-061. The weld is identified as BK004A1-061-009. The weld is CJP butt joint, joining to Top plate (BKPL1A) to Top plate (BKPL2A). The Material thickness is 16 mm.

This QA generated an Incident Report on this date for the above issue, for further information see the incident report and the attached photos.
